ENVIRONMENTAL performance in 2015

UPM Fray Bentos

UPM Fray Bentos Environmental Performance in 2015 is a supplement to the Corporate Environmental Statement of UPM's pulp and paper mills (available at www.upm.com) and provides mill-specific environmental performance data and trends for the year 2015. The annually updated mill supplements and the UPM Corporate Environmental Statement together form the joint EMAS Statement of UPM Corporation. The next Corporate Environmental Statement and also this supplement will be published in 2017.

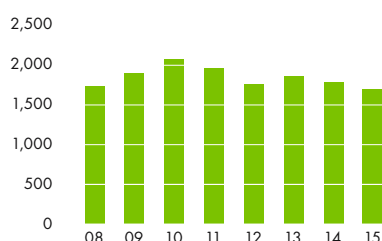
NITROGEN OXIDES, NO_x

t/a (measured as NO₂)

Considering the uncertainty in the continuous NO_x measurement for the lime kiln, its NO_x emissions were above the permit limit during an unusual amount of hours during the first four months of the year (21% of the time), but the annual exceedance was within the tolerance of the environmental authorization. These unusual levels of NO_x were related to tests performed in order to implement a new high level control strategy for the lime kiln. After the control system was implemented, NO_x emissions from the lime kiln returned to normal levels.
